# TEALwatch

## Power Quality Analysis

Facility:	<b>Memorial Hospital</b> <b>1234 Mockingbird Lane</b> <b>Springfield, TX 12345</b>	Protected Equipment:	<b>Acme Phytoscan 4700</b>
TEAL Model #:	<b>PCDU-Phyto-U</b>	TEALWatch Serial #:	<b>00027</b>
TEAL Serial #:	<b>A-023456-1</b>	TEALwatch Site #:	<b>00010</b>
Primary Contact:	<b>Alfred Ganim</b>	TEALwatch Report #:	<b>00010A</b>
Company:	<b>Acme Medical Systems</b>	Secondary Contact:	<b>Karl Strauss</b>
Phone:	<b>(123) 456-7890</b>	Company:	<b>Strauss Consulting</b>
Email:	<b>Aganim@Acmeded.Com</b>	Phone:	<b>(818) 888-3434</b>
		Email:	<b>Kstrauss@Straussgroup.Com</b>

Intermittant system resets and lock-ups

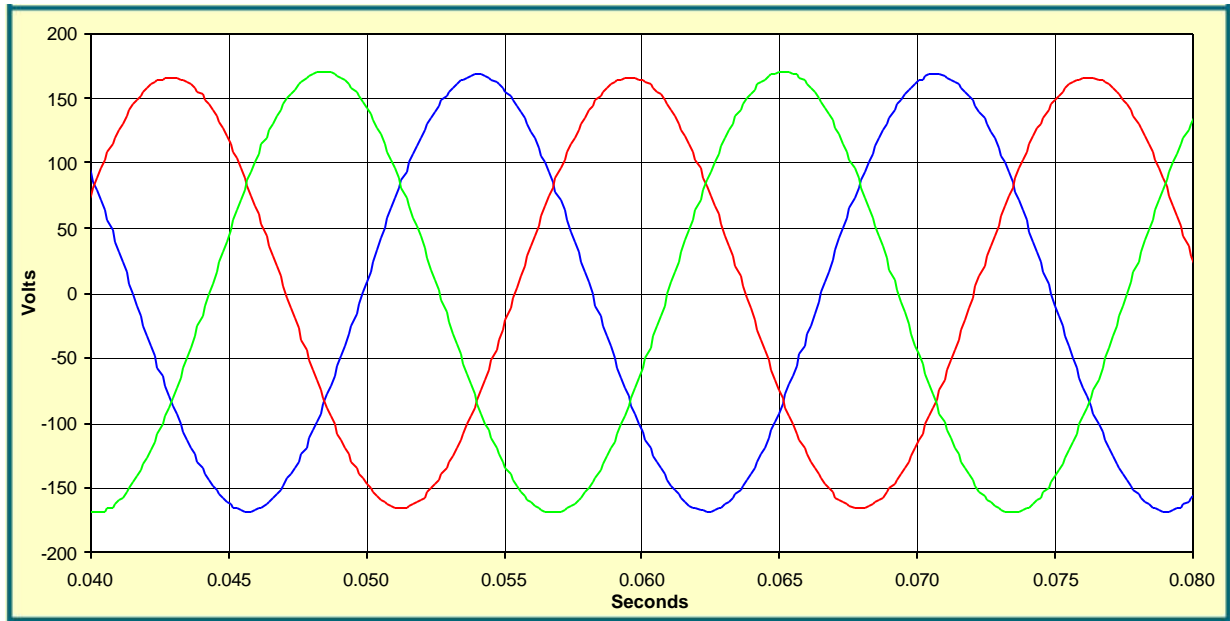
### RMS Voltage Snapshot

Voltage waveforms are sinusoidal, with a minimum of harmonic distortion.

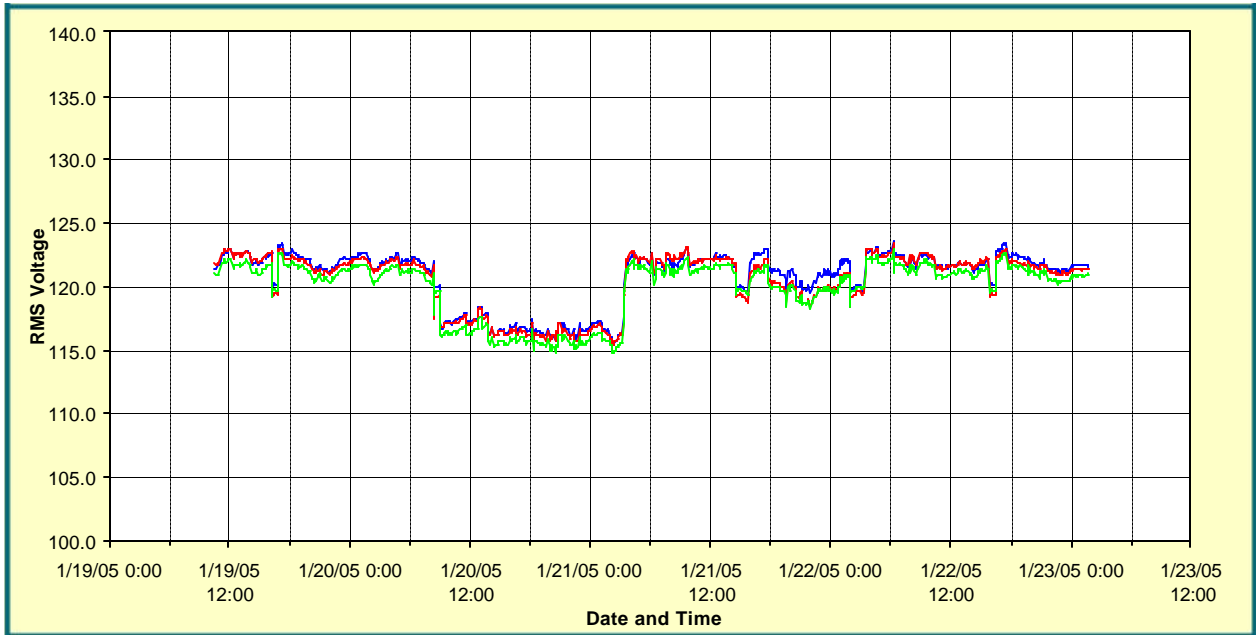
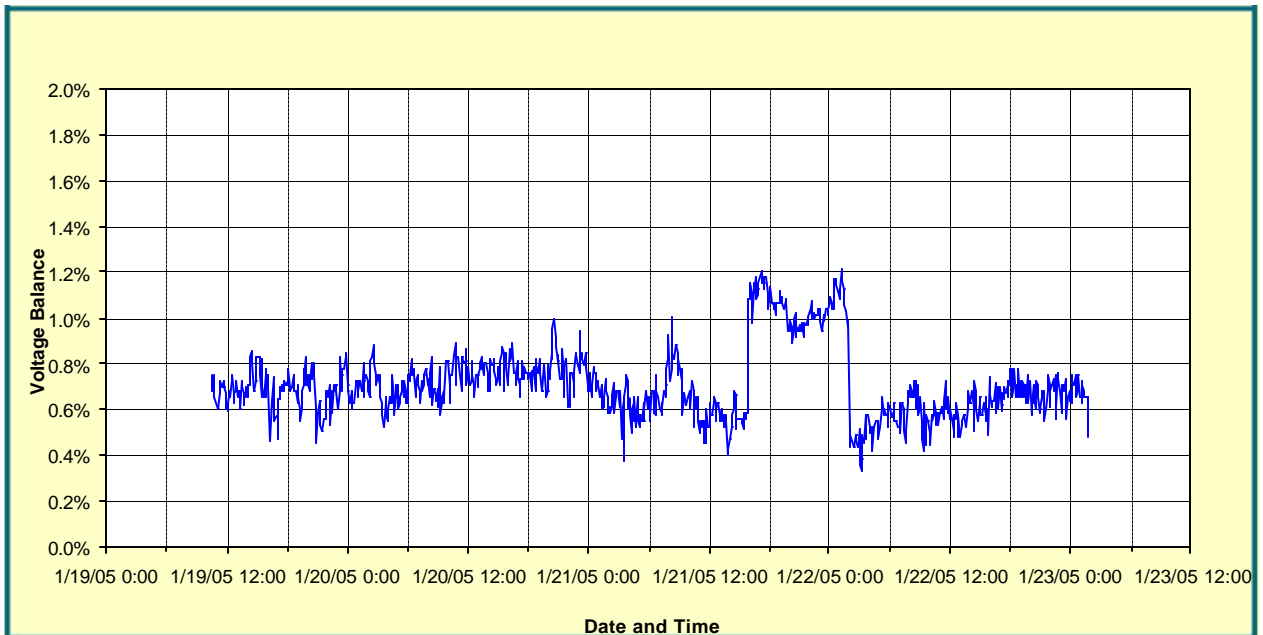
### RMS Voltage Trend Data – Full Monitoring Period

**RMS Voltages were acceptable throughout the monitored period.**

**Voltage Balance was less than 1% throughout the monitored period.**

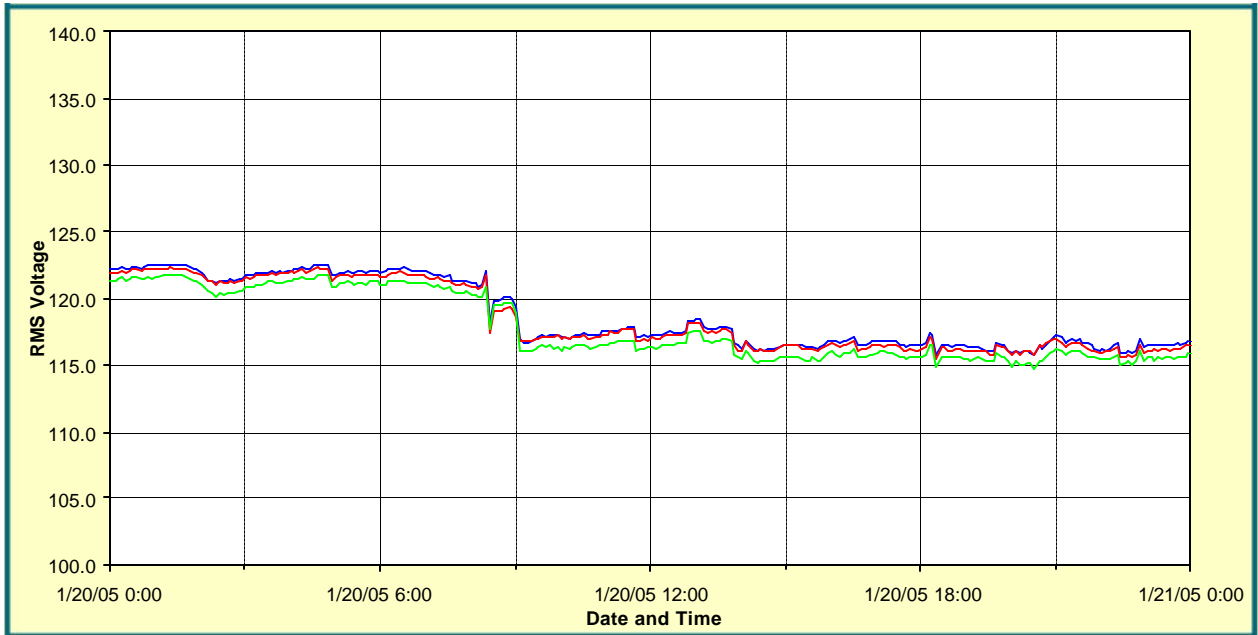
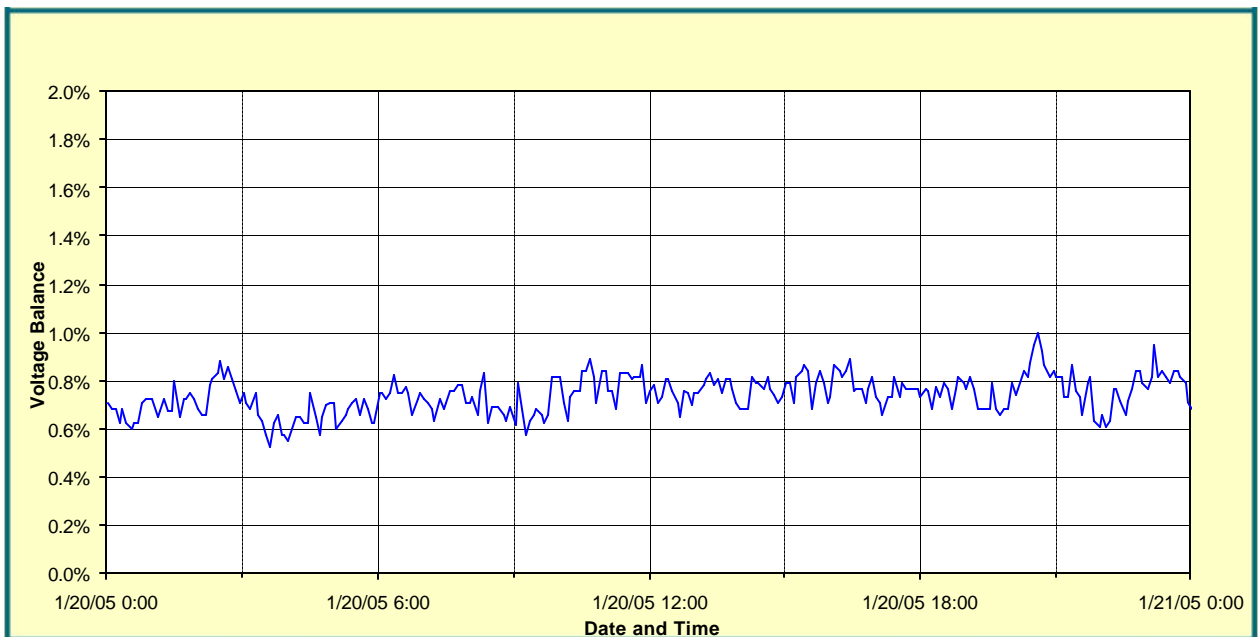
### RMS Voltage Trend Data – 24 Hour Period

**RMS Voltages were acceptable throughout the monitored period.**

**Voltage Balance was less than 1% throughout the monitored period.**

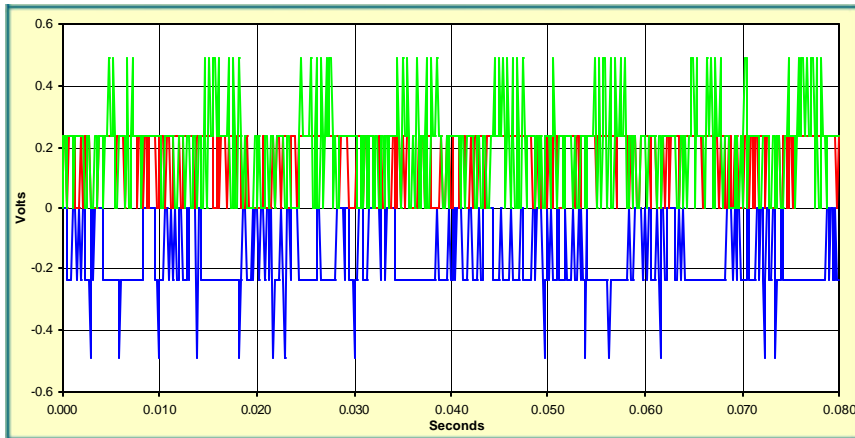
**Event Number:** 4

Voltage was not applied at the start of the monitored period.

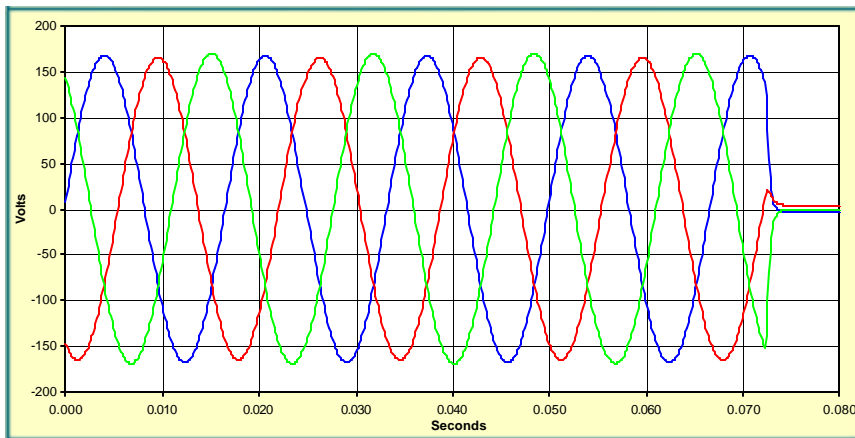
**Event Number:** 5

Loss of voltage, appears to be a local switch-off of power, and not a utility or facility-wide voltage failure.

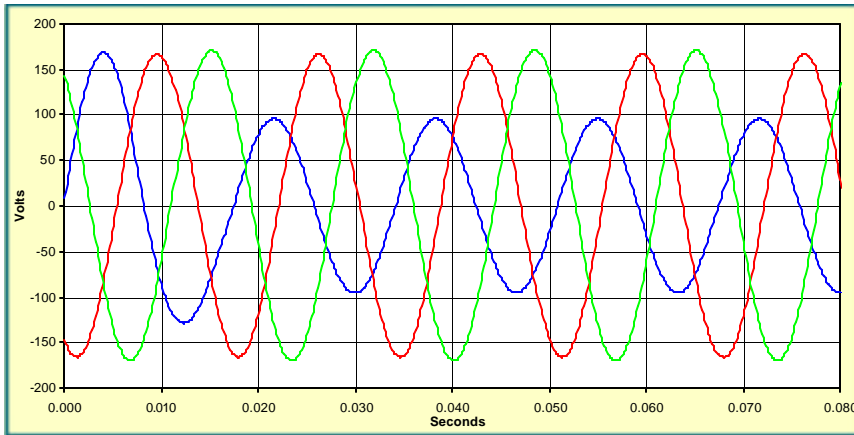
**Event Number:** 2  
**Date:** 1/19/2005  
**Time:** 10:27:04 AM  
**Duration:** 0.167  
**Minimum:** 67.4 VAC  
**Maximum:** 120.3 VAC  
**Analysis**  
 Severe voltage sag on Phase A only.

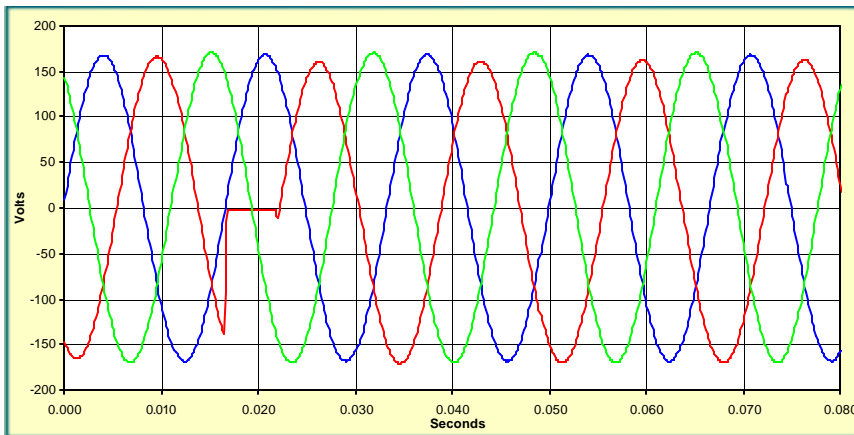
**Event Number:** 9  
**Date:** 1/19/2005  
**Time:** 3:44:08 PM  
**Duration:** 0.017  
**Minimum:** 88.6 VAC  
**Maximum:** 120.0 VAC  
**Analysis**  
 1/2 cycle drop-out on Phase B only.

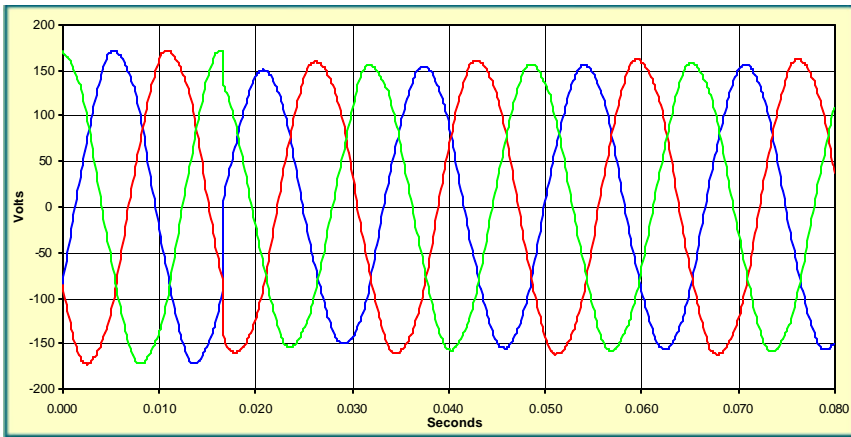
**Event Number:** 10  
**Date:** 1/21/2005  
**Time:** 3:57:20 PM  
**Duration:** 0.017  
**Minimum:** 94.0 VAC  
**Maximum:** 120.3 VAC

Small step in RMS voltage, probably a utility sag or large load switch-on.

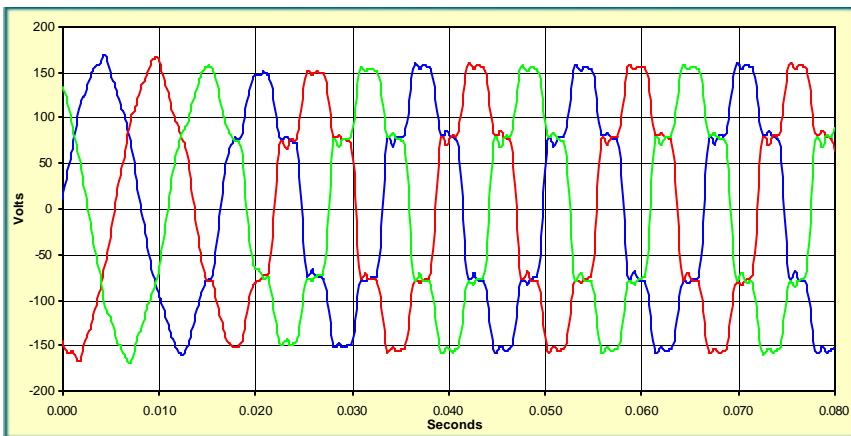
**Event Number:** 16  
**Date:** 1/21/2005  
**Time:** 3:59:42 PM  
**Duration:** 0.017  
**Minimum:** 90.6 VAC  
**Maximum:** 112.4 VAC

Step change in voltage waveform and amplitude, probably related to load switch-on and VRDU output impedance.

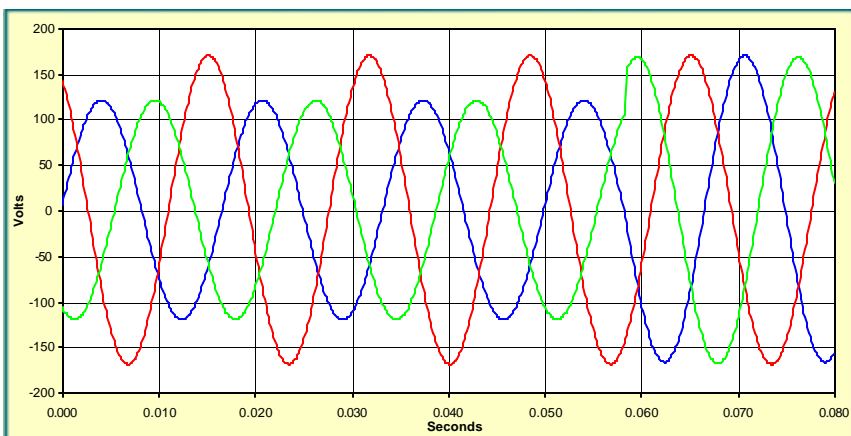
**Event Number:** 2  
**Date:** 1/19/2005  
**Time:** 10:27:04 AM  
**Duration:** 0.167  
**Minimum:** 67.4 VAC  
**Maximum:** 120.3 VAC

End of event 2, sag ends and voltage is restored.

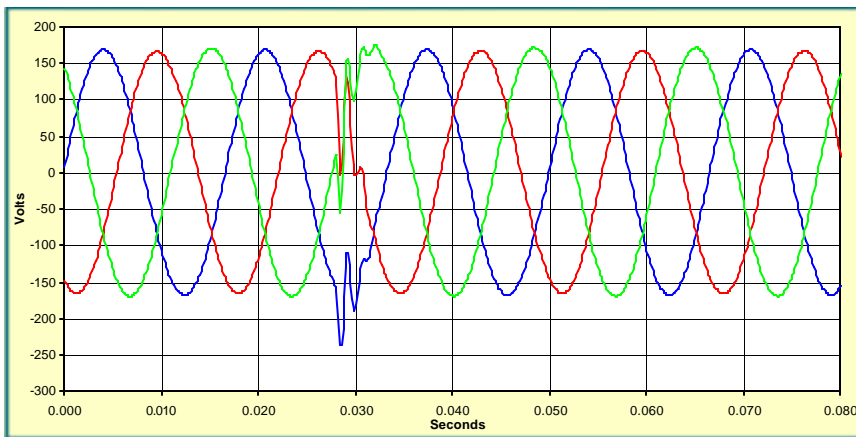
**Event Number:** 1

Low frequency transient, possibly related to utility switching or power factor capacitor switching.

<b>Voltage Transients</b>	Low frequency ringing transients were recorded.	Consider a UPS or power conditioner to protect the system from low frequency transients, if unexplained or intermittent system problems can be correlated to these transients.  Conventional TVSS devices do not provide protection from this type of transient.
<b>Load Generated Events</b>	Several apparent load generated disturbances were captured, and may indicate excessive source impedance.	Check the facility service and branch circuits to ensure they meet equipment requirements for conductor size, transformer size, and ratings.

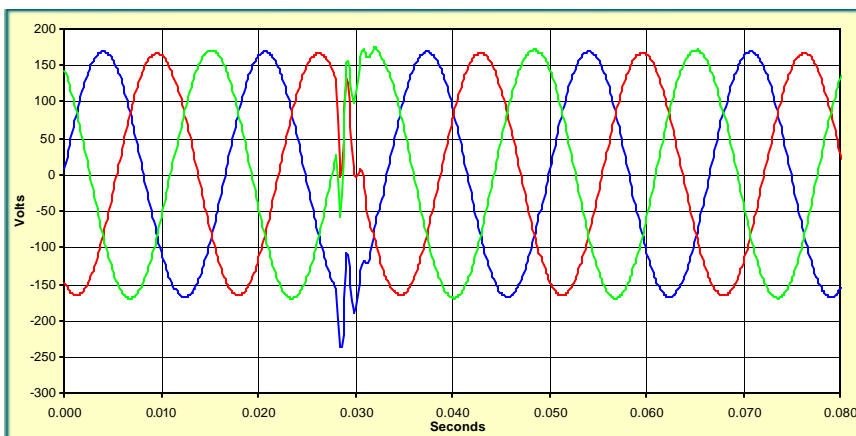
**Event Number:** 3

Low frequency transient, possibly related to utility switching or power factor capacitor switching.

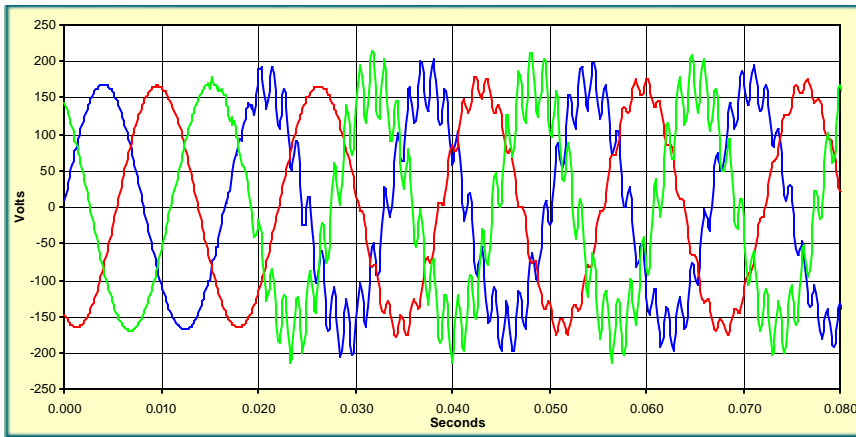
**Event Number:** 7

Sudden change in voltage waveform / ringing - possibly related to power conditioner or resonant capacitors.

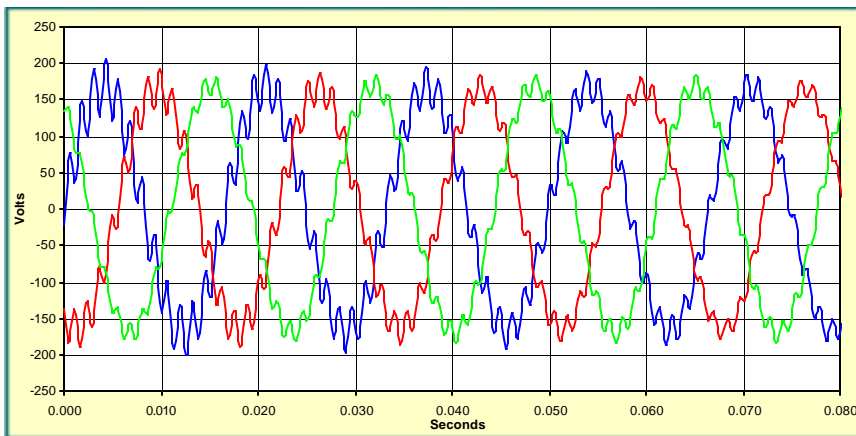
**Event Number:** 8

Continued ringing waveform distortion.

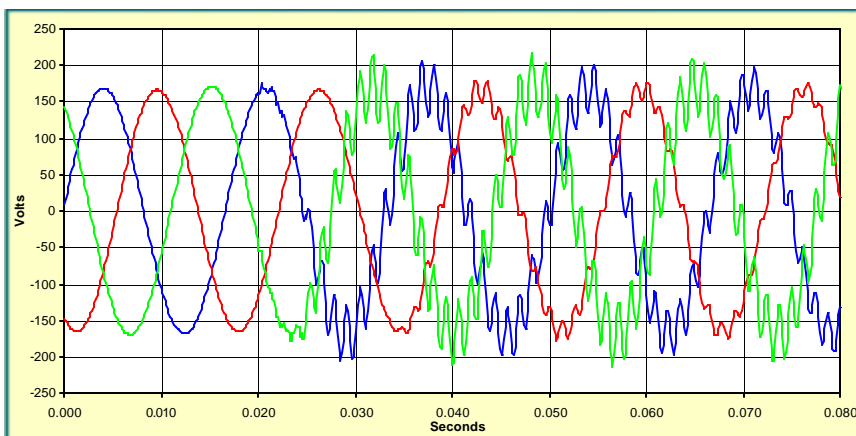
**Event Number:** 11

Sudden change in voltage waveform / ringing - possibly related to power conditioner or resonant capacitors.

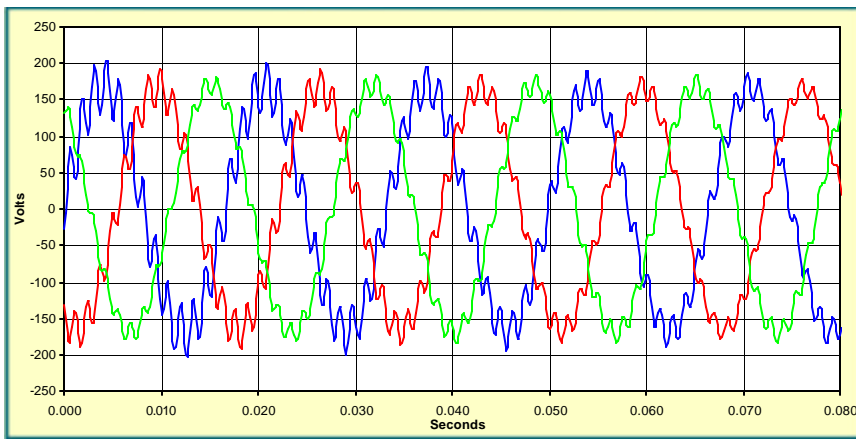
**Event Number:** 12  
**Date:** 1/21/2005  
**Time:** 3:58:07 PM  
**Analysis**  
Continued ringing waveform distortion.

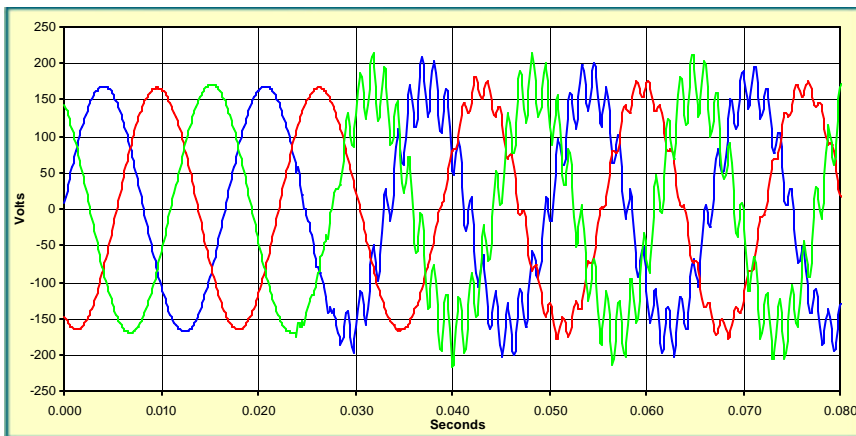
**Event Number:** 13  
**Date:** 1/21/2005  
**Time:** 3:59:23 PM  
**Analysis**  
Sudden change in voltage waveform / ringing - possibly related to power conditioner or resonant capacitors.

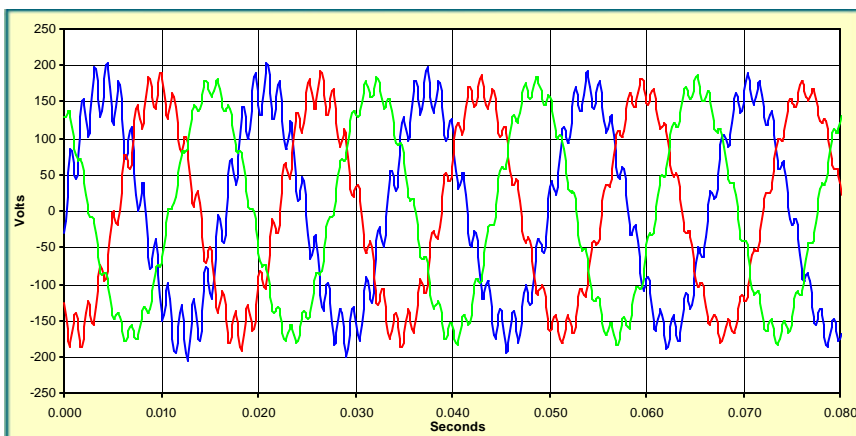
**Event Number:** 14  
**Date:** 1/21/2005  
**Time:** 3:59:23 PM  
**Analysis**  
Continued ringing waveform distortion.

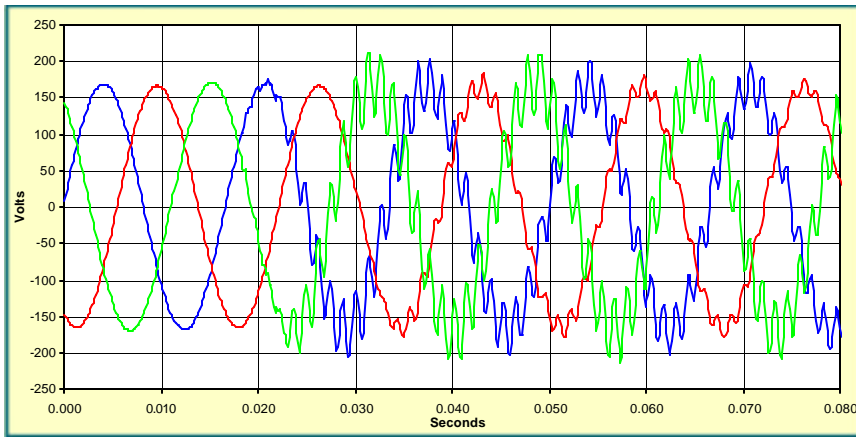
**Event Number:** 15  
**Date:** 1/21/2005  
**Time:** 3:59:40 PM

Sudden change in voltage waveform / ringing - possibly related to power conditioner or resonant capacitors.

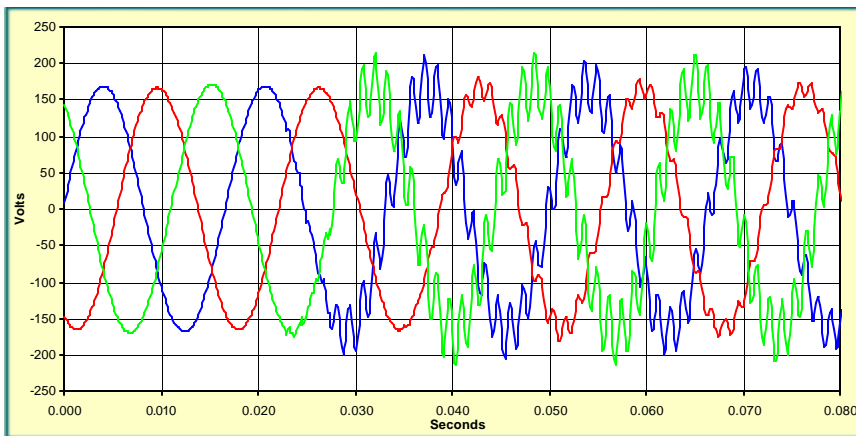
**Event Number:** 17  
**Date:** 1/21/2005  
**Time:** 3:59:47 PM

Sudden change in voltage waveform / ringing - possibly related to power conditioner or resonant capacitors.

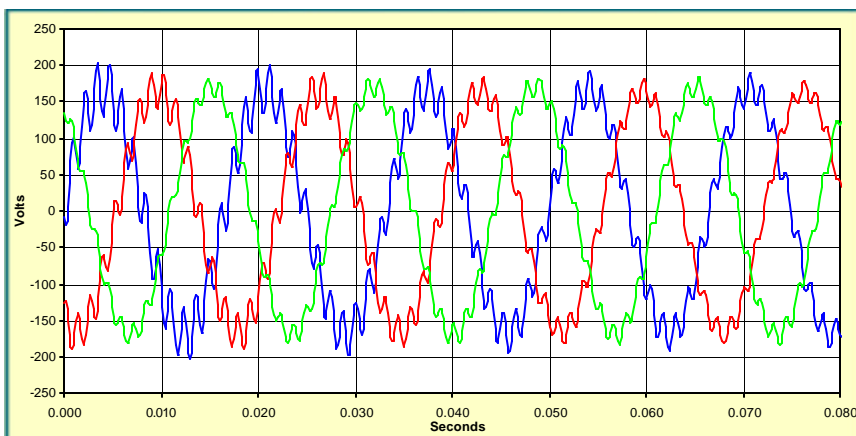
**Event Number:** 18  
**Date:** 1/21/2005  
**Time:** 3:59:47 PM

Continued ringing waveform distortion.

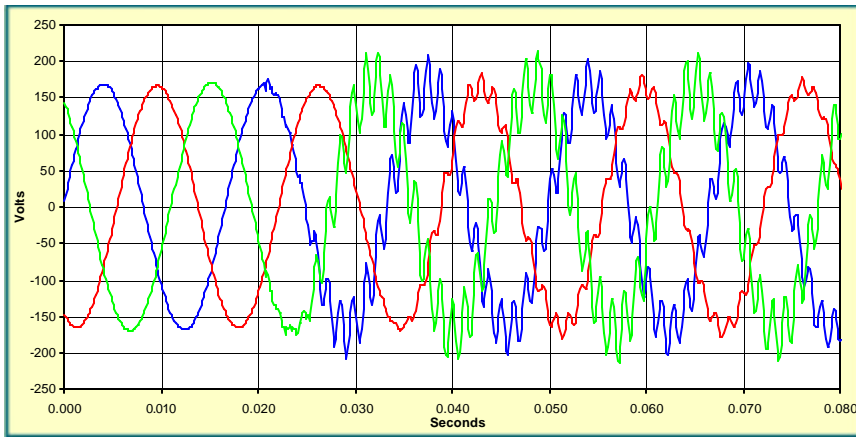
**Event Number:** 19  
**Date:** 1/21/2005  
**Time:** 3:59:57 PM

Sudden change in voltage waveform / ringing - possibly related to power conditioner or resonant capacitors.

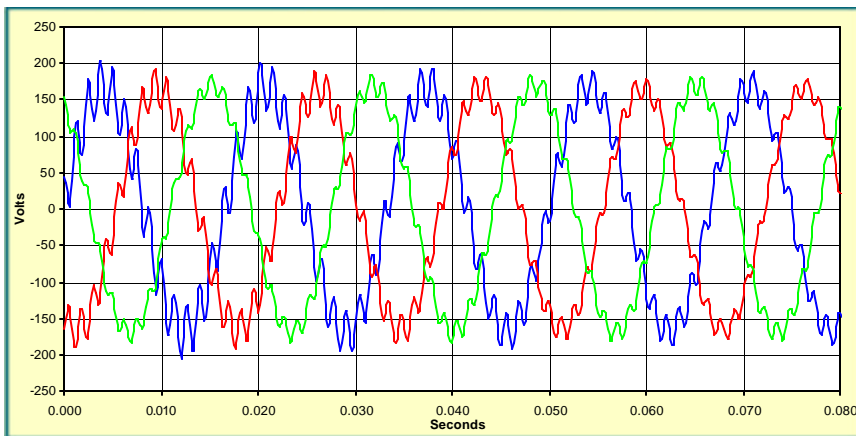
**Event Number:** 20  
**Date:** 1/21/2005  
**Time:** 3:59:57 PM

Continued ringing waveform distortion.
